SUBJECT: Transmittal of Response to PRP Complaint Regarding Well
Installation Activities at the Richardson Flats Tailings Site;
TDD #T08-9207-019

RICHARDSON FLATS TAILINGS SITE
SUMMIT COUNTY, UTAH
TDD #T08-9207-019

TAT Response to Pioneer Technical Services, Inc.
Comments and Observations Report
Dated July 13, 1992

COMMENTS AND OBSERVATIONS
ON THE DRILLING ACTIVITIES PERFORMED BY
EPA's TAT CONTRACTOR
AND SUBCONTRACTED DRILLER
DURING THE PERIOD OF
JUNE 23 THROUGH JUNE 27, 1992

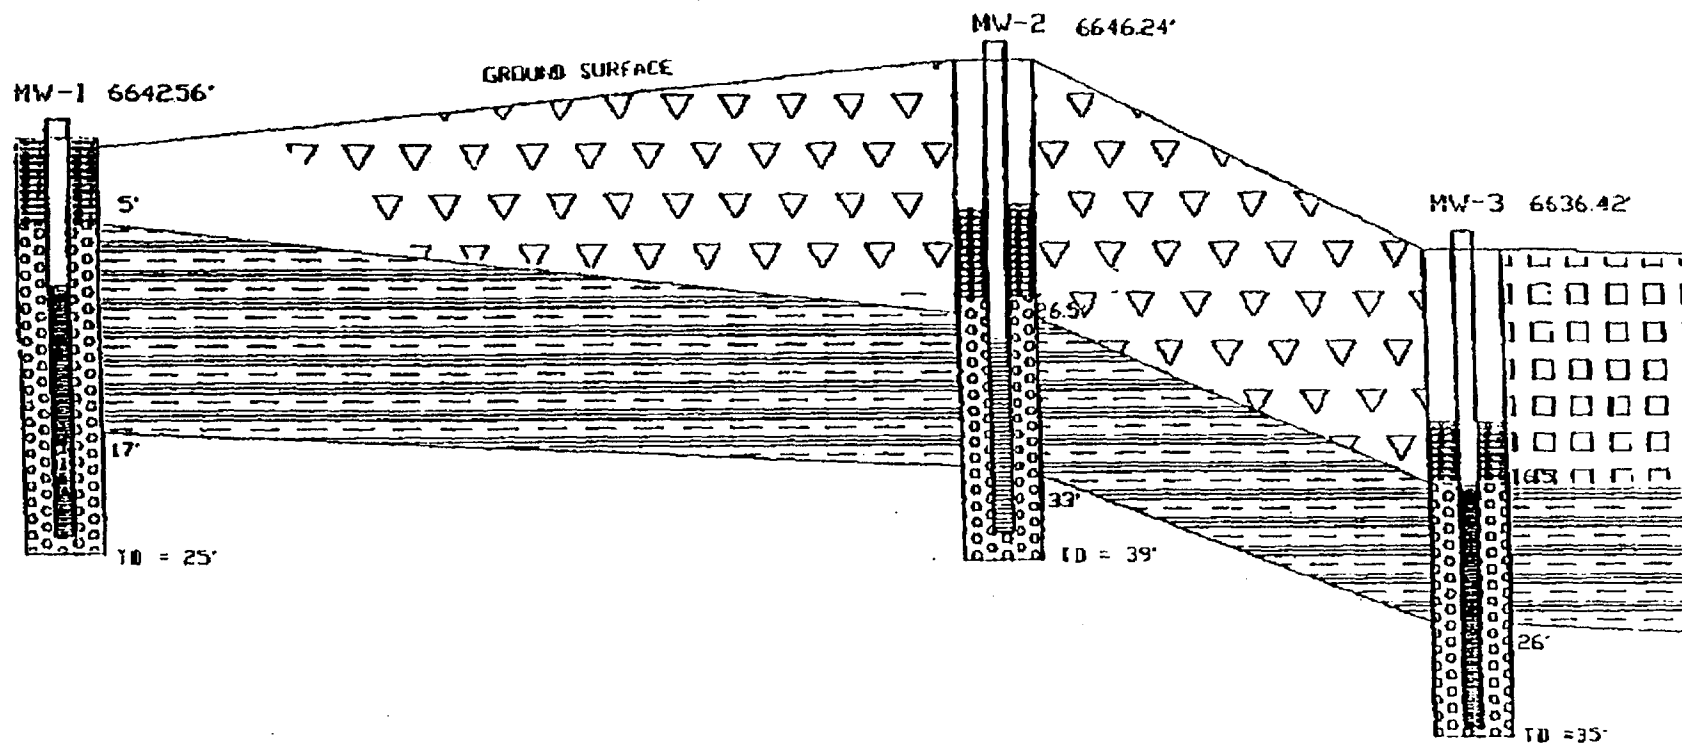
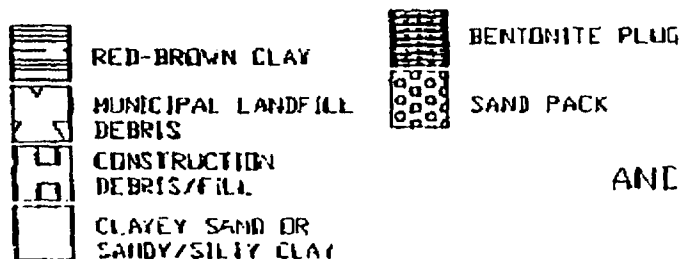
FIGURE 2
GEOLOGIC CROSS SECTION
AND LANDFILL MONITORING WELLS

This is the most egregious violation of sound hydrogeologic practice and may have violated State of Utah regulations for monitoring wells, water wells, or groundwater protection. The drilling of all three monitoring wells showed that the underlying groundwater was a confined or semi-confined aquifer system. In each borehole, the saturated zones were found beneath a thick, apparently continuous aquitard that isolated the landfill materials from underlying groundwater system (see cross-section, Figure 2). In each of the three monitoring wells, the static water level rose to an elevation significantly higher than the level at which water was first encountered.

Borehole MW-1 (upgradient) first encountered this aquitard at 5 feet below ground surface (bgs) and the first groundwater at 16 to 18 feet below the surface (the base of the aquitard). The

After ill-advisedly locating well MW-2 within the former landfill (discussed above), drilling commenced. For whatever reason, the TAT did not closely monitor the drill cuttings from the borehole; however, UPCM's hydrogeologist was because of the geology observed at MW-1 and concern about breaching the aquitard underlying the landfill. At 25 ft bgs, a two-foot split spoon core revealed six inches of the aquitard (a reddish-brown clay) in the bottom of the core barrel, clearly showing the top of the aquitard to be at 26.5 ft bgs. The TAT erroneously recorded the top of this unit at 25 ft bgs. Drilling continued (slowly) and water was encountered between 34 and 35 ft bgs. The drilling was halted at 39 ft bgs and well completion activities began.

At this point, serious errors in judgment and perhaps criminal negligence, caused the completion of well MW-2 to be entirely inappropriate, if not illegal. First, 10 feet of screen were placed in the well, bringing the screened section up to 27.5 ft bgs, very close to the top of the aquitard unit. Then, the filter pack was brought up to 26 ft bgs, above the aquitard. The bentonite seal placed on top of the sand was intended to plug the aquitard; however, due to careless geologic logging, it completely missed the aquitard and provides no such seal. The formerly continuous barrier between the landfill materials and groundwater has been breached by the drilling and not repaired during well construction. Water level measurements on subsequent days show clearly that the underlying water is under pressure and has risen up the borehole to exactly 26.5 ft bgs, the top of the aquitard. The underlying groundwater is now flowing up the well under pressure, out through the filter pack along the top of the clay aquitard and into the base of the formerly dry landfill. When this water discharges from the base of the landfill, either as springs or to Silver Creek, it will be contaminated by whatever is in the landfill.

In any event, the serious nature of the well construction disaster described above is at least unprofessional and at worst illegal. I recommend that all of these wells be properly abandoned as soon as possible. It is especially critical that MW-2 be plugged so that it does not continue to flood the landfill.

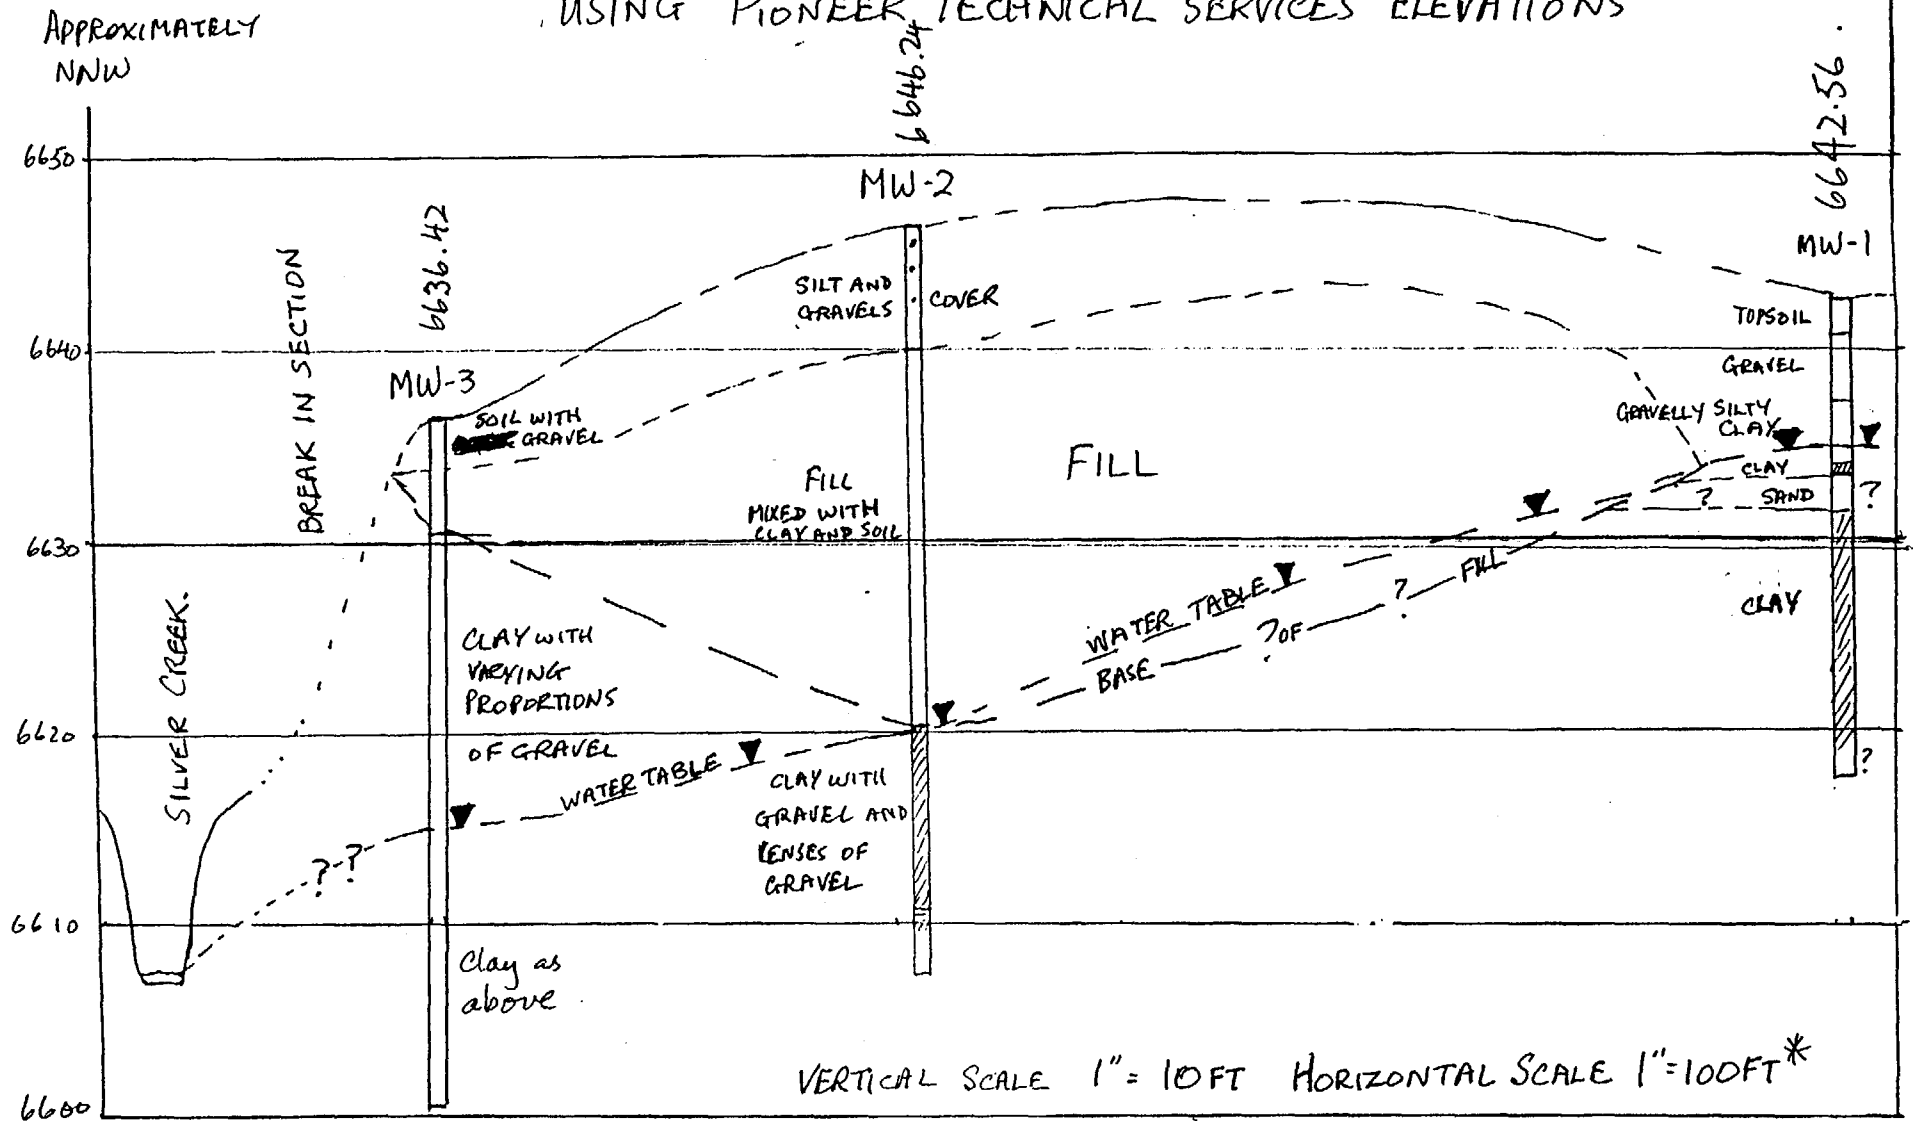
RICHARDSON FLATS TAILINGS SITE - SUMMIT CO. UTAH
 CROSS-SECTION THROUGH TAT BOREHOLES
 USING PIONEER TECHNICAL SERVICES ELEVATIONS

- ~~the~~ apparently irreconcilable descriptions of
geologic conditions observed during logging by
the TAT, and those described by PTS in their text;
- the preparation of a cross-section by PTS
which is not compatible with well logs prepared
by the TAT and not substantiated by any alternative
well logs;
- a plan of the ~~site~~ site prepared by PTS which

Very typically when drilling into sediments such as clay, the water table is not obvious during boring, and obviously saturated conditions are not encountered until well beneath the subsequently determined water table elevation.

This is because the rate of flow of water into the borehole is slight, especially because of the compression of clays ^{against} the borehole wall. Also, with the method of drilling used, the upper parts of the hole are cased off. When left open for some time or when completed as a well, the slow leakage of water from the borehole wall results in the gradual rise of the water until equilibrium is established.
